Pentium® II Processor Specification Update

Release Date: June 1999

Order Number: 243337-027

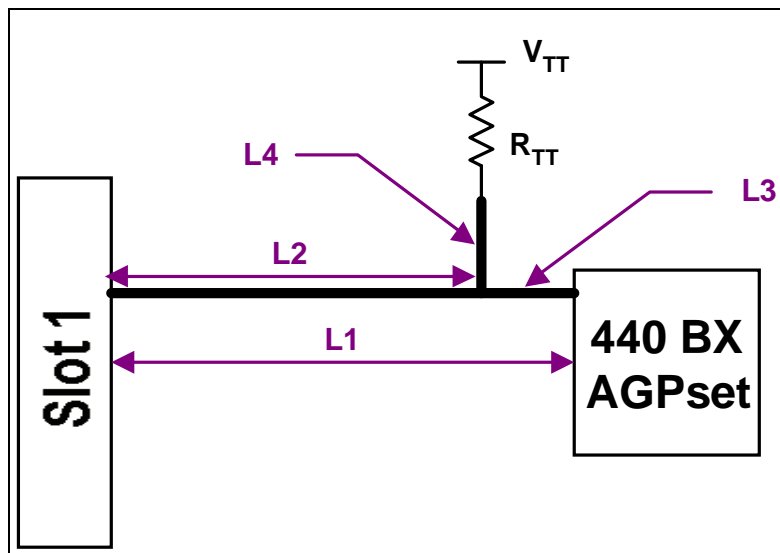
Figure 1. UP Dual Ended Termination (DET)

IMPLICATION: This violation of the bus exchange protocol when using a reduced arbitration latency may cause a system-level setup timing violation on the address, address parity, request command, or request parity signals on the system bus. This may result in a system hang or assertion of the AERR# signal, causing an attempted corrective action or shutdown of the system, as the system hardware and software dictate. The possibility of failure due to the contention caused by this erratum may be increased due to the processor's internal active pull-up of these signals on the clock after the signals are no longer being driven by the processor.

For UP-DET topologies (see Figure 1), the trace length L1 must be between 1.5" to 4.5" while using a 56Ω termination resistor.
